**Flood Control Project Maintenance  
Levee Inspections**  
**LMA District Cover Sheet**  
**Spring 2018 Levee Inspection Results**

**Reclamation District No. 2101 Blewett**

**Spring 2018 Levee Inspection Results**

Waterway			Bank	Unit Miles
Unit No. 01 San Joaquin River			Left	3.16
	Spring (March - May)	Summer (June - August)	(September - November) Fall	Winter (December - February)
Unit Maintenance Rating (Fall Only)				
Date of Inspection	3/8/2018 - 3/8/2018			
DWR Inspector	Maksim Khashchuk			
Accompanied By	Jim Coddington RD2101

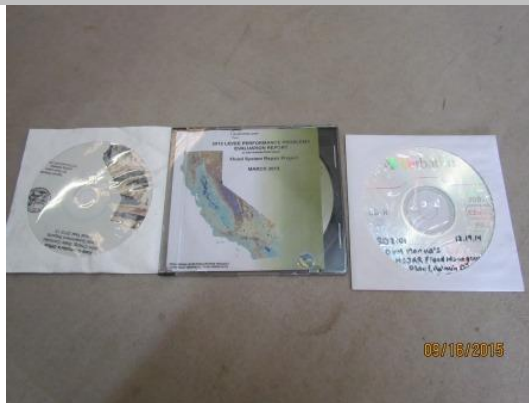
Photo 1 of 1 : SP\_2018\_RD2101\_326\_2\_20180305\_00003.jpg

View of the O&amp;M manual and other documentation.

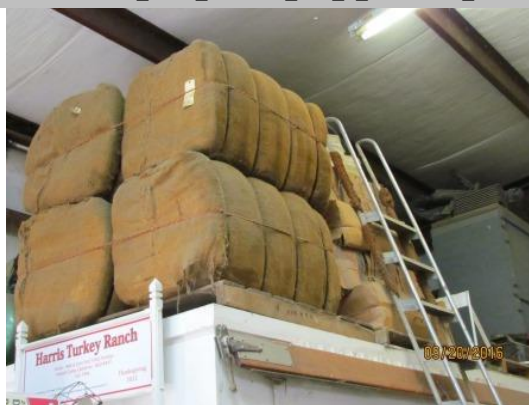
Photo 1 of 2 : SP\_2018\_RD2101\_326\_4\_20180305\_00004.jpg

LM Start		Rating **	A	Issue No.	4		
LM End		Issue Type +	Ma	Location *	N/A		
Category	Earthen Levee			GPS Latitude/Longitude			
				Start		End	
Item	Emergency Supplies & Equipment				o		o
					o		o
DWR ID	DWR_RD2101_01_s_2013_4						
Comment Code							
Inspector Comment							
LMA has emergency supplies on site at the warehouse.

View of the emergency flood fight supplies in the shop.

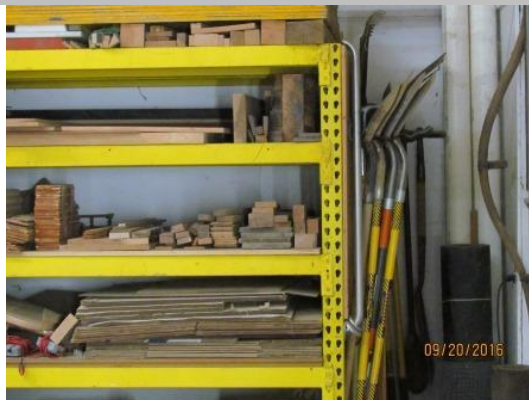
Photo 2 of 2 : SP\_2018\_RD2101\_326\_4\_20180305\_00005.jpg

Another view of the emergency flood fight supplies in the shop.

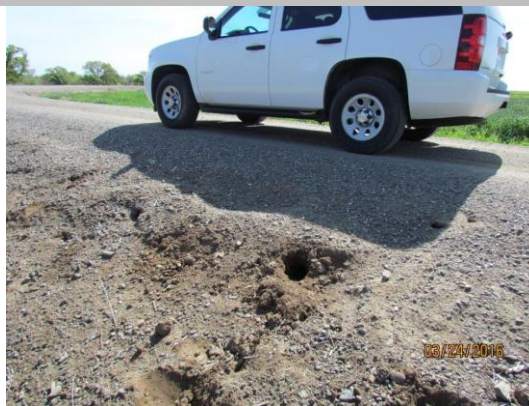
Photo 1 of 1 : SP\_2018\_RD2101\_326\_12\_20180305\_00007.jpg

View of the rodent holes on the waterside levee slope, facing upstream.

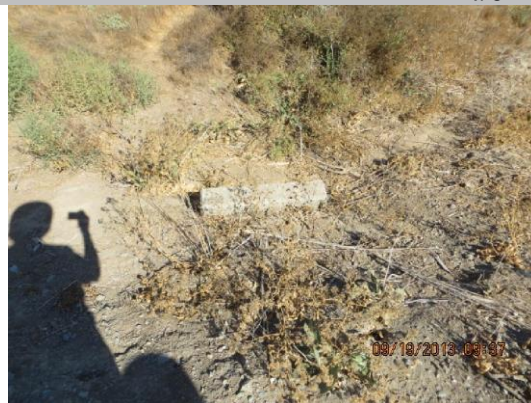
Photo 1 of 3 : UCIP\_SP\_2018\_51391\_47962.jpg

Comment Code						
Inspector Comment						
FS_ID:51391 DS_ID:20699 EP_NO: N/A Repair Type: Urgent Crossing Status: Found UCIP Comments: 11/16/2016 Same as previous inspection slide gate still missing. Also dense vegetation prevents access to crossing. Recommend removing vegetation along pipe alignment and both concrete headwalls to conduct proper inspection of structure. (O. Magana - DWR UCIP)09/17/2013 Slide gate missing from WS toe. Pipe has heavy sediment buildup. (W. Wylie - DWR UCIP) FIELD_STRUCT_DESC: 18-inch corrugated metal drainage pipe through the levee, 3 feet below the crown. Concrete headwalls on both ends. Slide gate at the headwall on the waterside (WS) end. [Additional Reference(s): DWR Levee Log, 1992. USACE San Joaquin O&M Manual 12, December 1968, (HLM 0.05), Drawing No. 07-04-1666, Sheets 1666/18 and 1666/52, (Station 00+70)]. FS Date: 11/16/2016

Headwall on WS toe.

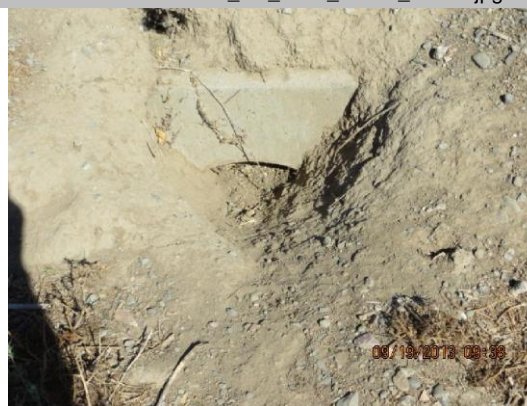
Photo 3 of 3 : UCIP\_SP\_2018\_51391\_47960.jpg

Comment Code						
Inspector Comment						
FS_ID:51391 DS_ID:20699 EP_NO: N/A Repair Type: Urgent Crossing Status: Found UCIP Comments: 11/16/2016 Same as previous inspection slide gate still missing. Also dense vegetation prevents access to crossing. Recommend removing vegetation along pipe alignment and both concrete headwalls to conduct proper inspection of structure. (O. Magana - DWR UCIP)09/17/2013 Slide gate missing from WS toe. Pipe has heavy sediment buildup. (W. Wylie - DWR UCIP) FIELD_STRUCT_DESC: 18-inch corrugated metal drainage pipe through the levee, 3 feet below the crown. Concrete headwalls on both ends. Slide gate at the headwall on the waterside (WS) end. [Additional Reference(s): DWR Levee Log, 1992. USACE San Joaquin O&M Manual 12, December 1968, (HLM 0.05), Drawing No. 07-04-1666, Sheets 1666/18 and 1666/52, (Station 00+70)]. FS Date: 11/16/2016

Pipe and headwall visible on LS toe.

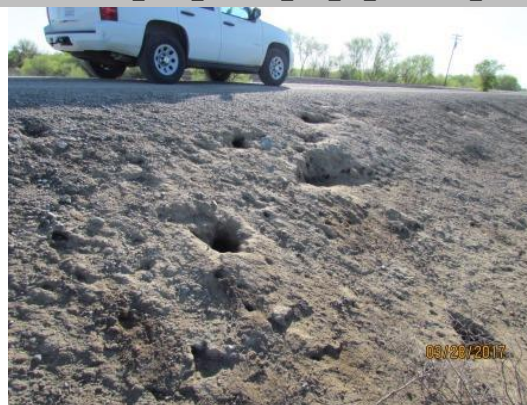
Photo 1 of 1 : SP\_2018\_RD2101\_326\_15\_20180305\_00008.jpg

LM Start	0.12	Rating **	A/W	Issue No.	15
LM End	0.12	Issue Type +	Ma	Location *	LS
Category	Earthen Levee			GPS Latitude/Longitude	
				Start	End
Item	Animal Control			37.657348 °	37.657348 °
				-121.252660 °	-121.252660 °
DWR ID	DWR_RD2101_01_s_2017_15				
Comment Code					
A1 : Exterminate rodents and backfill and compact or grout burrows.					
Inspector Comment					
LMA backfilled rodent holes, but there is still rodent activity.

View of the rodent burrows on the levee slope.

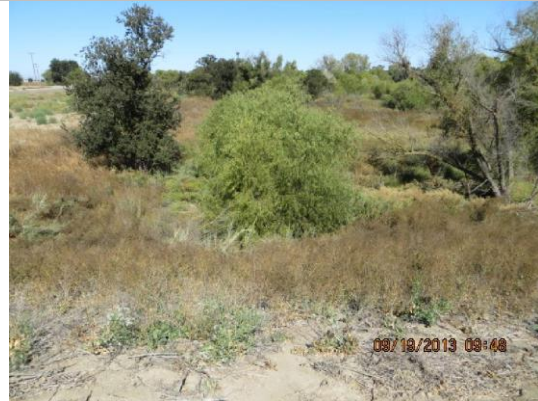
Photo 3 of 3 : UCIP\_SP\_2018\_20752\_34978.jpg

LM Start	0.20	Rating **	A/W	Issue No.	946 (cont)	
LM End	0.20	Issue Type +	Ma	Location *		
Category	Supplemental			GPS Latitude/Longitude		
				Start	End	
Item	DWR UCIP LMA Responsibility			37.657130 °	37.657130 °	
				-121.251695 °	-121.251695 °	
DWR ID						
Comment Code						
Inspector Comment						
FS_ID:20752						
DS_ID:20700						
EP_NO: N/A						
Repair Type: No Action Needed						
Crossing Status: Found						
UCIP Comments:						
FIELD_STRUCT_DESC: 20-inch steel drainage pipe through the levee, 2 feet below the crown. Concrete U-shaped headwall and flap gate on the waterside (WS) end. Pump on pile structure on the landside (LS). [Additional Reference(s): DWR Levee Log, 1992. USACE San Joaquin O&M Manual 12, December 1968, (HLM 0.20), 18-inch pipe listed].						
FS Date: 9/19/2013

Concrete U-shaped headwall on LS toe at willow tree on WS toe.

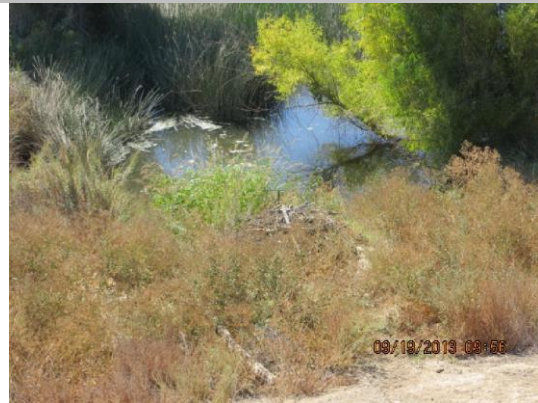
Photo 1 of 3 : UCIP\_SP\_2018\_20785\_35046.jpg

LM Start	0.31	Rating **	M	Issue No.	947
LM End	0.31	Issue Type +	Ma	Location *	
Category	Supplemental			GPS Latitude/Longitude	
				Start	End
Item	DWR UCIP LMA Responsibility			37.658142 °	37.658142 °
				-121.250047 °	-121.250047 °
DWR ID					
Comment Code					
Inspector Comment					
FS_ID:20785					
DS_ID:20701					
EP_NO: N/A					
Repair Type: Non-Urgent					
Crossing Status: Found					
UCIP Comments: Inlet blocked by soil from beaver activity. Outlet covered in soil.					
FIELD_STRUCT_DESC: 24-inch corrugated metal drainage pipe through the levee, 21 feet below the crown. Headwall and slide gate on the landside (LS) end. Concrete U-shaped headwall and flap gate on the waterside (WS) end. [Additional Reference(s): DWR Levee Log, 1992. USACE San Joaquin O&M Manual 12, December 1968, (HLM 0.31)].					
FS Date: 9/19/2013

Slide gate at concrete headwall on LS toe.

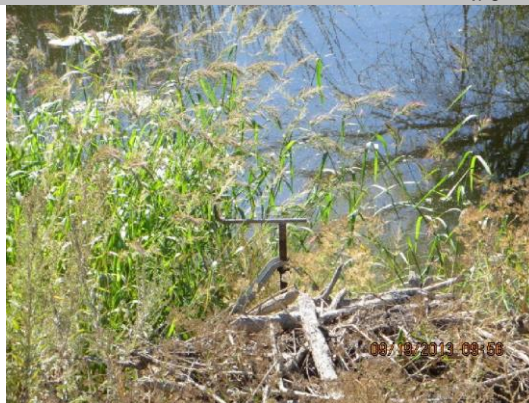
Photo 2 of 3 : UCIP\_SP\_2018\_20785\_35045.jpg

LM Start	0.31	Rating **	M	Issue No.	947 (cont)	
LM End	0.31	Issue Type +	Ma	Location *		
Category	Supplemental			GPS Latitude/Longitude		
				Start		End
Item	DWR UCIP LMA Responsibility			37.658142 °	37.658142 °	
				-121.250047 °	-121.250047 °	
DWR ID						
Comment Code						
Inspector Comment						
FS_ID:20785 DS_ID:20701 EP_NO: N/A Repair Type: Non-Urgent Crossing Status: Found UCIP Comments: Inlet blocked by soil from beaver activity. Outlet covered in soil. FIELD_STRUCT_DESC: 24-inch corrugated metal drainage pipe through the levee, 21 feet below the crown. Headwall and slide gate on the landside (LS) end. Concrete U-shaped headwall and flap gate on the waterside (WS) end. [Additional Reference(s): DWR Levee Log, 1992. USACE San Joaquin O&M Manual 12, December 1968, (HLM 0.31)]. FS Date: 9/19/2013

Slide gate at concrete headwall on LS toe.

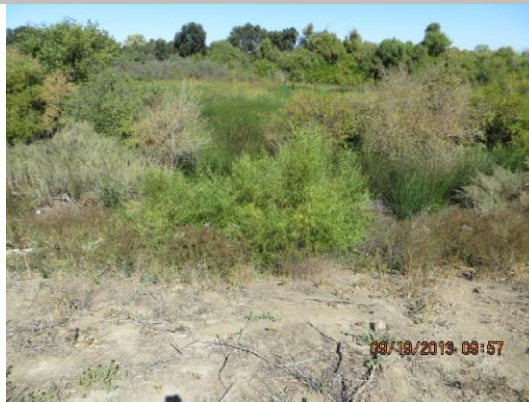
Photo 3 of 3 : UCIP\_SP\_2018\_20785\_35044.jpg

Outlet covered in soil but likely at willow tree on WS slope.

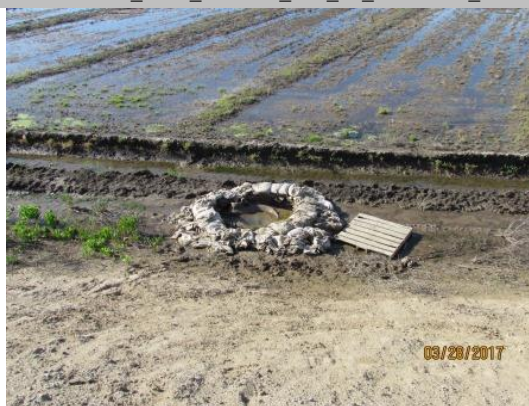
Photo 1 of 1 : SP\_2018\_RD2101\_326\_16\_20180305\_00009.jpg

View of the boil and seepage area at the levee toe.

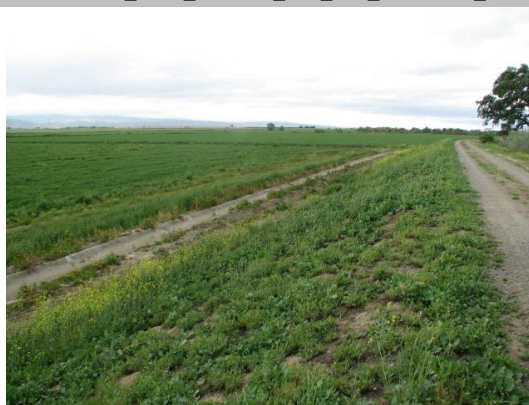
Photo 1 of 1 : SP\_2018\_RD2101\_326\_944\_20180305\_00025.jpg

Concrete ditch near landside toe.

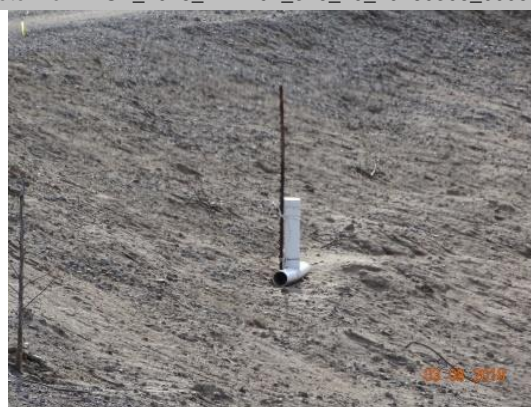
Photo 1 of 1 : SP\_2018\_RD2101\_326\_19\_20180308\_00055.jpg

View of the bait station on the levee slope.

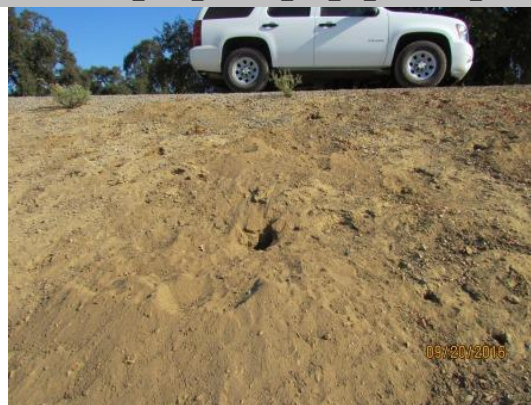
Photo 1 of 1 : SP\_2018\_RD2101\_326\_21\_20180305\_00010.jpg

LM Start	0.86	Rating **	M	Issue No.	21
LM End	0.86	Issue Type +	Ma	Location *	LS
Category	Earthen Levee			GPS Latitude/Longitude	
				Start	End
Item	Animal Control			37.658715 °	37.658715 °
				-121.241945 °	-121.241945 °
DWR ID	DWR_RD2101_01_f_2016_21				
Comment Code					
A1 : Exterminate rodents and backfill and compact or grout burrows.					
Inspector Comment

View of the rodent hole on the landside slope.

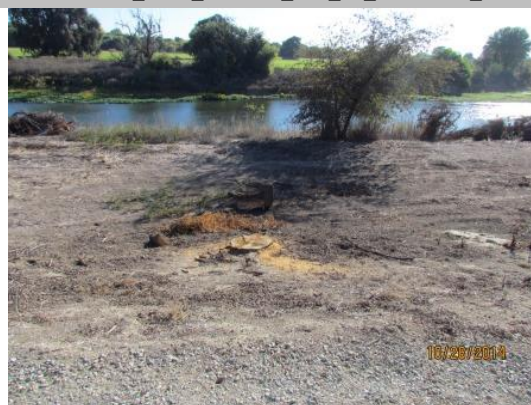
Photo 1 of 1 : SP\_2018\_RD2101\_326\_33\_20180305\_00019.jpg

View of the tree stump at the waterside levee toe.

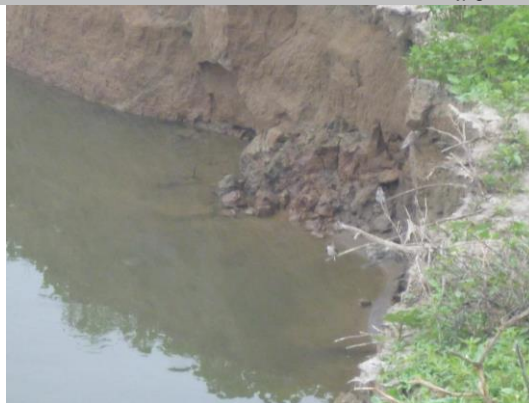
Photo 3 of 3 : LEVAL\_SP\_2018\_133\_228.jpg

LM Start	1.87	Rating **	A/W	Issue No.	39 (cont)
LM End	1.96	Issue Type +	Ma	Location *	
Category	Supplemental			GPS Latitude/Longitude	
				Start	End
Item	2017 Storm Damage			37.650550 °	37.649980 °
				-121.229570 °	-121.228040 °
DWR ID	DWR_RD2101_01_f_2017_39				
Comment Code					
Inspector Comment					
Levee Evaluation Comments					
Description:					
Site ID No:133					
Site Designation:DWR_RD2101_01_s_2012_1					
Repair Type: Erosion					
Rating:Critical					
Field Date:6/8/2017					
Notes: Lineal cracking on the levee crown is visible. Erosion scarp is near vertical. This site was repaired at the time of the Fall 2017 inspection.

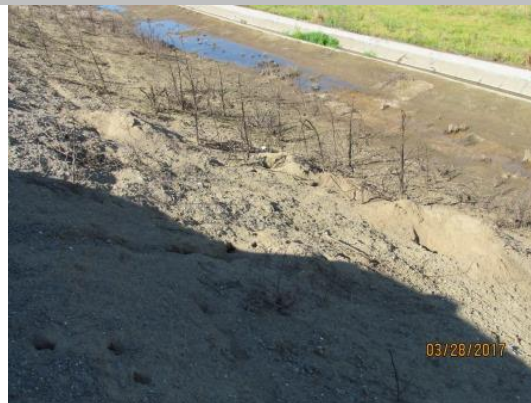
Photo 1 of 1 : SP\_2018\_RD2101\_326\_36\_20180305\_00020.jpg

View of the multiple rodent burrows on the levee slope.

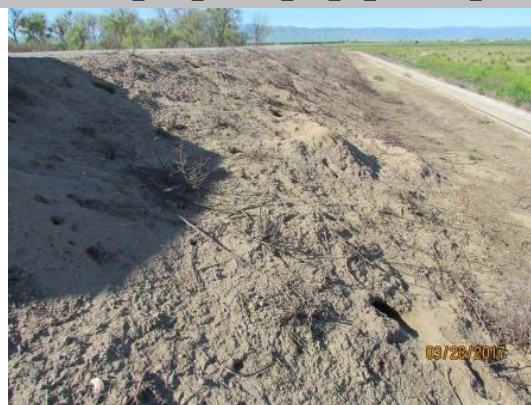
Photo 1 of 1 : SP\_2018\_RD2101\_326\_37\_20180305\_00021.jpg

LM Start	2.67	Rating **	U	Issue No.	37
LM End	2.67	Issue Type +	Ma	Location *	LS
Category	Earthen Levee			GPS Latitude/Longitude	
				Start	End
Item	Animal Control			37.642436 °	37.642436 °
				-121.229854 °	-121.229854 °
DWR ID	DWR_RD2101_01_s_2017_37				
Comment Code					
A1 : Exterminate rodents and backfill and compact or grout burrows.					
Inspector Comment

View of the multiple rodent burrows on the levee slope.

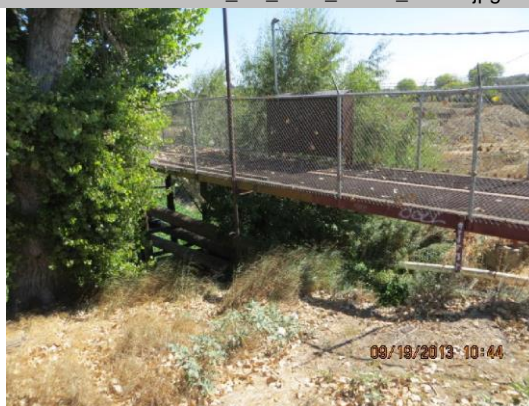
Photo 1 of 3 : UCIP\_SP\_2018\_20865\_35110.jpg

LM Start	2.71	Rating **	M	Issue No.	948	
LM End	2.71	Issue Type +	En	Location *		
Category	Supplemental			GPS Latitude/Longitude		
				Start		End
Item	DWR UCIP Field Study			37.641976 °	37.641976 °	
				-121.229745 °	-121.229745 °	
DWR ID						
Comment Code						
Inspector Comment						
FS_ID:20865 DS_ID:20711 EP_NO: N/A Repair Type: Non-Urgent Crossing Status: Found UCIP Comments: Pipe leaking at pipe/concrete connection on WS slope. FIELD_STRUCT_DESC: 2 of 3: 20-inch concrete encased steel irrigation pipe through the levee, 10 feet below the crown. Pump on steel pier on the waterside (WS). Gate valve in a 16-foot by 7-foot concrete vault on the WS shoulder. Pipes discharge into a concrete canal on the landside (LS) toe. [Additional Reference(s): DWR Levee Log, 1992. USACE San Joaquin O&M Manual 12, December 1968, (HLM 2.73)]. FS Date: 9/19/2013

Pump on metal pier on WS.

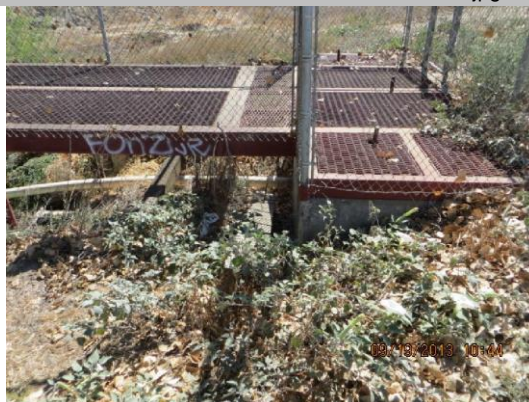
Photo 2 of 3 : UCIP\_SP\_2018\_20865\_35109.jpg

Gate valve in concrete vault on WS shoulder.

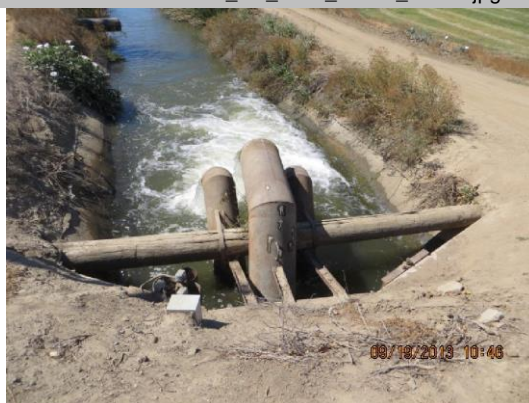
Photo 3 of 3 : UCIP\_SP\_2018\_20865\_35108.jpg

LM Start	2.71	Rating **	M	Issue No.	948 (cont)	
LM End	2.71	Issue Type +	En	Location *		
Category	Supplemental			GPS Latitude/Longitude		
				Start		End
Item	DWR UCIP Field Study			37.641976 °		37.641976 °
				-121.229745 °		-121.229745 °
DWR ID						
Comment Code						
Inspector Comment						
FS_ID:20865 DS_ID:20711 EP_NO: N/A Repair Type: Non-Urgent Crossing Status: Found UCIP Comments: Pipe leaking at pipe/concrete connection on WS slope. FIELD_STRUCT_DESC: 2 of 3: 20-inch concrete encased steel irrigation pipe through the levee, 10 feet below the crown. Pump on steel pier on the waterside (WS). Gate valve in a 16-foot by 7-foot concrete vault on the WS shoulder. Pipes discharge into a concrete canal on the landside (LS) toe. [Additional Reference(s): DWR Levee Log, 1992. USACE San Joaquin O&M Manual 12, December 1968, (HLM 2.73)]. FS Date: 9/19/2013

20-inch steel pipe discharges into concrete channel on LS.

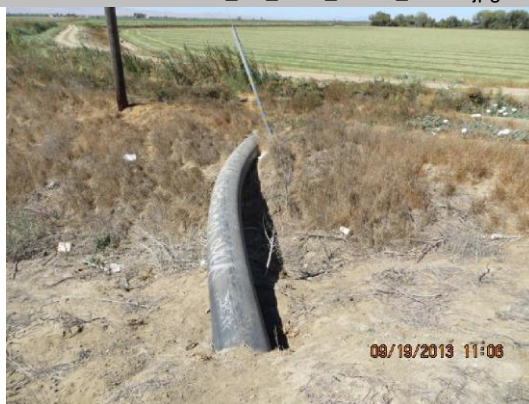
Photo 1 of 2 : UCIP\_SP\_2018\_22915\_39043.jpg

LM Start	2.72	Rating **	M	Issue No.	949
LM End	2.72	Issue Type +	En	Location *	
Category	Supplemental			GPS Latitude/Longitude	
				Start	End
Item	DWR UCIP Field Study			37.641798 °	37.641798 °
				-121.229714 °	-121.229714 °
DWR ID					
Comment Code					
Inspector Comment					
FS_ID:22915 DS_ID:24679 EP_NO: N/A Repair Type: Non-Urgent Crossing Status: Found UCIP Comments: 09/26/2016 - (T. Hatch/UCIP) Inspector indicated that pipe had been removed for several years. Need additional information to determine if the pipe was removed properly and the levee recompacted to specifications. 09/19/2013 - (W. Wylie/UCIP) No permit identified for this crossing. FIELD_STRUCT_DESC: *REMOVED* 18-inch polyvinyl chloride (PVC) irrigation pipe through the levee, 3.5 feet below the crown. No pump or other appurtenances visible. FS Date: 9/19/2013

18-inch PVC pipe visible at LS slope.

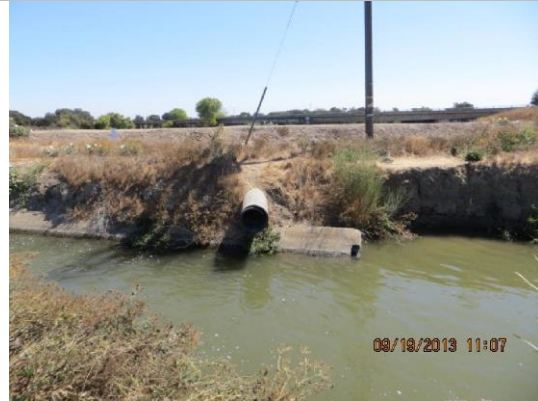
Photo 2 of 2 : UCIP\_SP\_2018\_22915\_39042.jpg

LM Start	2.72	Rating **	M	Issue No.	949 (cont)	
LM End	2.72	Issue Type +	En	Location *		
Category	Supplemental			GPS Latitude/Longitude		
				Start	End	
Item	DWR UCIP Field Study			37.641798 °	37.641798 °	
				-121.229714 °	-121.229714 °	
DWR ID						
Comment Code						
Inspector Comment						
FS_ID:22915 DS_ID:24679 EP_NO: N/A Repair Type: Non-Urgent Crossing Status: Found UCIP Comments: 09/26/2016 - (T. Hatch/UCIP) Inspector indicated that pipe had been removed for several years. Need additional information to determine if the pipe was removed properly and the levee recompacted to specifications. 09/19/2013 - (W. Wylie/UCIP) No permit identified for this crossing. FIELD_STRUCT_DESC: *REMOVED* 18-inch polyvinyl chloride (PVC) irrigation pipe through the levee, 3.5 feet below the crown. No pump or other appurtenances visible. FS Date: 9/19/2013

18-inch PVC pipe visible at outlet to irrigation canal on LS slope.

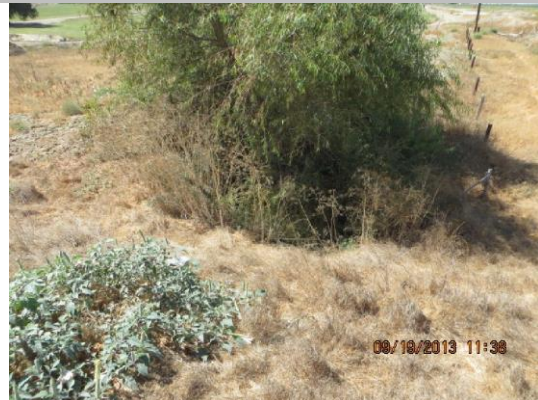
Photo 1 of 3 : UCIP\_SP\_2018\_51392\_35142.jpg

Comment Code						
Inspector Comment						
FS_ID:51392 DS_ID:20705 EP_NO: N/A Repair Type: Urgent Crossing Status: Found UCIP Comments: 11/16/2016 No access available. Need to coordinate with LMA to obtain access for proper inspection at a later date. (O. Magana - DWR UCIP)09/19/2013 Flap gate missing from WS headwall. (W. Wylie - DWR UCIP) FIELD_STRUCT_DESC: 24-inch corrugated metal drainage pipe through the levee, 11 feet below the crown. Concrete U-shaped headwalls on both ends. Flap gate on the waterside (WS) end. [Additional Reference(s): DWR Levee Log, 1992. USACE San Joaquin O&M Manual 12, December 1968, (HLM 2.85), Drawing No. 07-04-1666, Sheets 1666/13 and 1666/51, (Station 421+30)]. FS Date: 11/16/2016

Concrete headwall visible at LS toe in ditch.

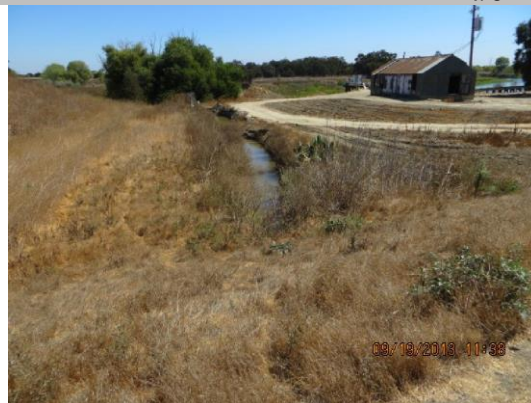
Photo 2 of 3 : UCIP\_SP\_2018\_51392\_35141.jpg

Comment Code					
Inspector Comment					
FS_ID:51392					
DS_ID:20705					
EP_NO: N/A					
Repair Type: Urgent					
Crossing Status: Found					
UCIP Comments: 11/16/2016 No access available. Need to coordinate with LMA to obtain access for proper inspection at a later date. (O. Magana - DWR UCIP)09/19/2013 Flap gate missing from WS headwall. (W. Wylie - DWR UCIP)					
FIELD_STRUCT_DESC: 24-inch corrugated metal drainage pipe through the levee, 11 feet below the crown. Concrete U-shaped headwalls on both ends. Flap gate on the waterside (WS) end.					
[Additional Reference(s): DWR Levee Log, 1992. USACE San Joaquin O&M Manual 12, December 1968, (HLM 2.85), Drawing No. 07-04-1666, Sheets 1666/13 and 1666/51, (Station 421+30)].					
FS Date: 11/16/2016

Concrete headwall visible on WS toe at canal.

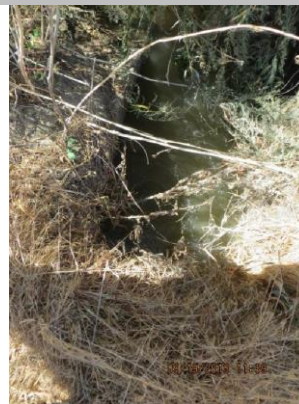
Photo 3 of 3 : UCIP\_SP\_2018\_51392\_35140.jpg

Concrete headwall at LS toe.

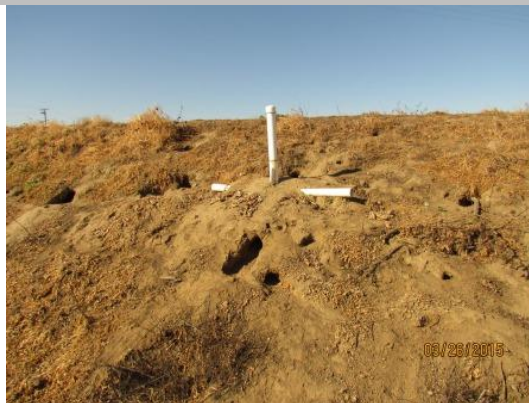
Photo 1 of 1 : SP\_2018\_RD2101\_326\_27\_20180305\_00014.jpg

LM Start	2.83	Rating **	U	Issue No.	27
LM End	2.83	Issue Type +	Ma	Location *	WS
Category	Earthen Levee			GPS Latitude/Longitude	
				Start	End
Item	Animal Control			37.640425 °	37.640425 °
				-121.230139 °	-121.230139 °
DWR ID	DWR_RD2101_01_s_2012_27				
Comment Code					
A3 : No rodents visible, but rodent burrows visible; need to backfill and compact or grout burrows.					
Inspector Comment					
Burrows on both sides of levee. Backfill the burrows to restore the levee to original condition.

View of multiple rodent holes on the levee slope.

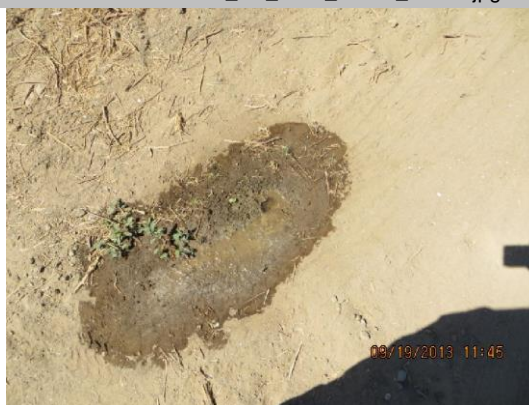
Photo 1 of 3 : UCIP\_SP\_2018\_20873\_35146.jpg

Comment Code					
Inspector Comment					
FS_ID:20873 DS_ID:20706 EP_NO: N/A Repair Type: Non-Urgent Crossing Status: Found UCIP Comments: Leaks off LS toe may indicate internal failure. Good candidate for video inspection. FIELD_STRUCT_DESC: 1 of 2: 24-inch reinforced concrete irrigation pipe through the levee, 11 feet below the crown. Pump on metal pier at the berm. Screw gates in a 6-foot by 10.5-foot concrete box on the waterside (WS). 12-inch steel riser next to concrete box with slide gates. Abandoned pump house on the WS. [Additional Reference(s): DWR Levee Log, 1992. USACE San Joaquin O&M Manual 12, December 1968, (HLM 2.87)]. FS Date: 9/19/2013

Leak in pipe off LS toe.

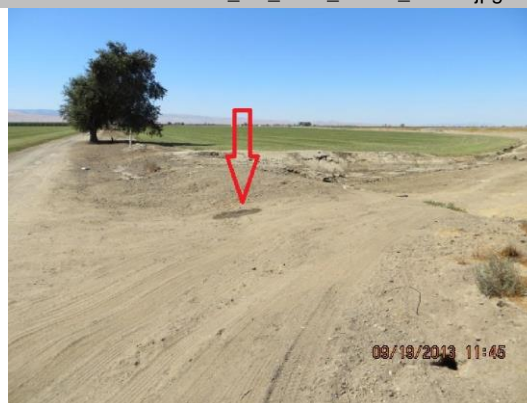
Photo 2 of 3 : UCIP\_SP\_2018\_20873\_35145.jpg

Comment Code						
Inspector Comment						
FS_ID:20873 DS_ID:20706 EP_NO: N/A Repair Type: Non-Urgent Crossing Status: Found UCIP Comments: Leaks off LS toe may indicate internal failure. Good candidate for video inspection. FIELD_STRUCT_DESC: 1 of 2: 24-inch reinforced concrete irrigation pipe through the levee, 11 feet below the crown. Pump on metal pier at the berm. Screw gates in a 6-foot by 10.5-foot concrete box on the waterside (WS). 12-inch steel riser next to concrete box with slide gates. Abandoned pump house on the WS. [Additional Reference(s): DWR Levee Log, 1992. USACE San Joaquin O&M Manual 12, December 1968, (HLM 2.87)]. FS Date: 9/19/2013

Leak in pipe off LS toe.

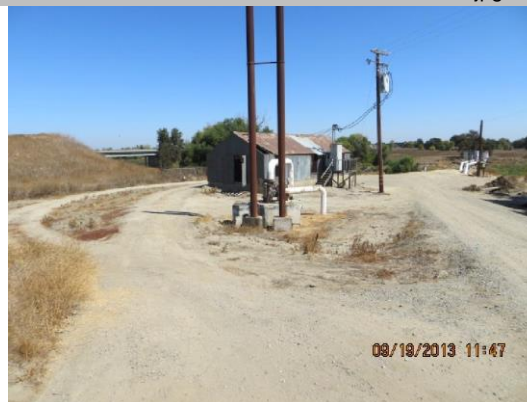
Photo 3 of 3 : UCIP\_SP\_2018\_20873\_35144.jpg

12-inch steel riser at concrete box with gatevalve on WS berm.

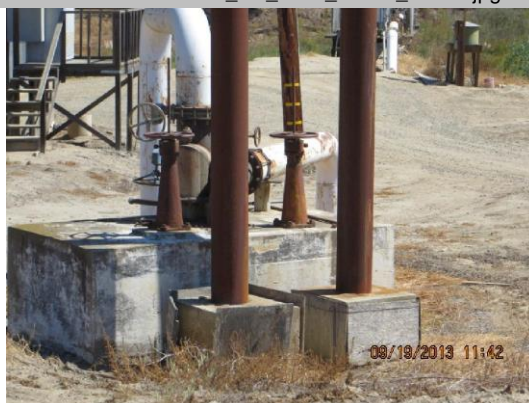
Photo 1 of 3 : UCIP\_SP\_2018\_20874\_35151.jpg

LM Start	2.85	Rating **	M	Issue No.	952
LM End	2.85	Issue Type +	En	Location *	
Category	Supplemental			GPS Latitude/Longitude	
				Start	End
Item	DWR UCIP Field Study			37.640185 °	37.640185 °
				-121.230067 °	-121.230067 °
DWR ID					
Comment Code					
Inspector Comment					
FS_ID:20874 DS_ID:20712 EP_NO: N/A Repair Type: Non-Urgent Crossing Status: Found UCIP Comments: Leak off LS toe may indicate internal failure. Good candidate for video inspection. FIELD_STRUCT_DESC: 2 of 2: 30-inch reinforced concrete irrigation pipe through the levee, 11 feet below the crown. Pump on metal pier on the berm. 12-inch steel riser next to a 6-foot by 10.5-foot concrete box with a screw gate inside on the waterside (WS). Abandoned pump house on the WS. [Additional Reference(s): DWR Levee Log, 1992. USACE San Joaquin O&M Manual 12, December 1968, (HLM 2.87)]. FS Date: 9/19/2013

Gatevalve in concrete vault with standpipe off WS toe.

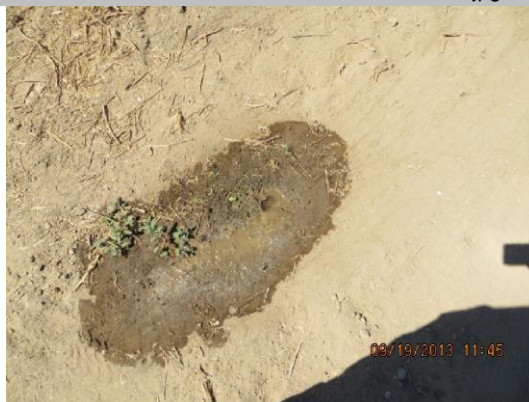
Photo 2 of 3 : UCIP\_SP\_2018\_20874\_35150.jpg

Leak in pipe off LS toe.

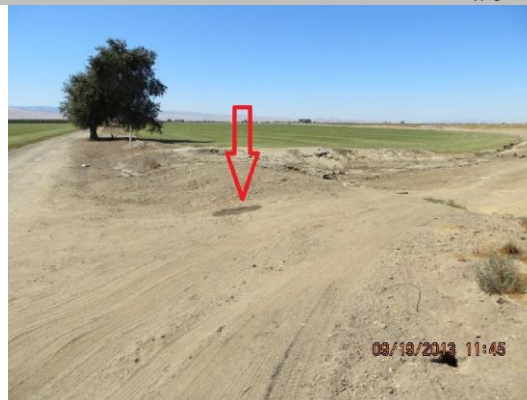
Photo 3 of 3 : UCIP\_SP\_2018\_20874\_35149.jpg

LM Start	2.85	Rating **	M	Issue No.	952 (cont)	
LM End	2.85	Issue Type +	En	Location *		
Category	Supplemental			GPS Latitude/Longitude		
				Start		End
Item	DWR UCIP Field Study			37.640185 °		37.640185 °
				-121.230067 °		-121.230067 °
DWR ID						
Comment Code						
Inspector Comment						
FS_ID:20874 DS_ID:20712 EP_NO: N/A Repair Type: Non-Urgent Crossing Status: Found UCIP Comments: Leak off LS toe may indicate internal failure. Good candidate for video inspection. FIELD_STRUCT_DESC: 2 of 2: 30-inch reinforced concrete irrigation pipe through the levee, 11 feet below the crown. Pump on metal pier on the berm. 12-inch steel riser next to a 6-foot by 10.5-foot concrete box with a screw gate inside on the waterside (WS). Abandoned pump house on the WS. [Additional Reference(s): DWR Levee Log, 1992. USACE San Joaquin O&M Manual 12, December 1968, (HLM 2.87)]. FS Date: 9/19/2013

Leak in pipe off LS toe.

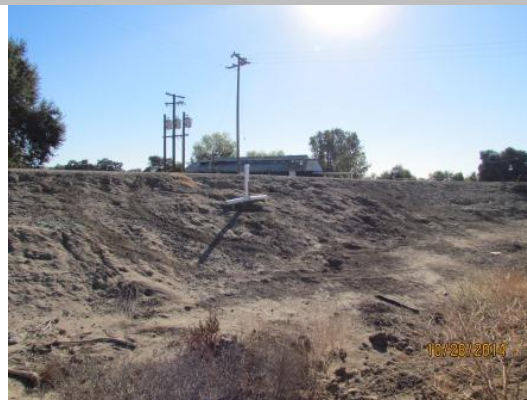
Photo 1 of 1 : SP\_2018\_RD2101\_326\_28\_20180305\_00015.jpg

View of numerous rodent holes with bait stations present.

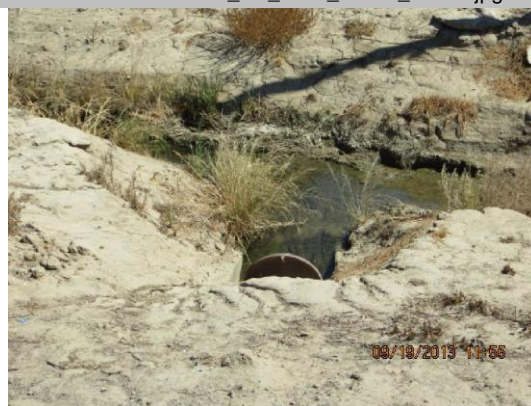
Photo 1 of 3 : UCIP\_SP\_2018\_20875\_35156.jpg

LM Start	2.87	Rating **	A/W	Issue No.	953
LM End	2.87	Issue Type +	Ma	Location *	
Category	Supplemental			GPS Latitude/Longitude	
				Start	End
Item	DWR UCIP LMA Responsibility			37.639924 °	37.639924 °
				-121.230005 °	-121.230005 °
DWR ID					
Comment Code					
Inspector Comment					
FS_ID:20875					
DS_ID:20707					
EP_NO: N/A					
Repair Type: No Action Needed					
Crossing Status: Found					
UCIP Comments:					
FIELD_STRUCT_DESC: 1 of 2: 24-inch corrugated metal drainage pipe					
through the levee, 12.5 feet below the crown. Concrete U-shaped					
headwalls on each end. Flap gate on the waterside (WS) end.					
[Additional Reference(s): DWR Levee Log, 1992. USACE San Joaquin					
O&M Manual 12, December 1968, (HLM 2.89)].					
FS Date: 9/19/2013

Flapgate on WS toe at concrete headwall.

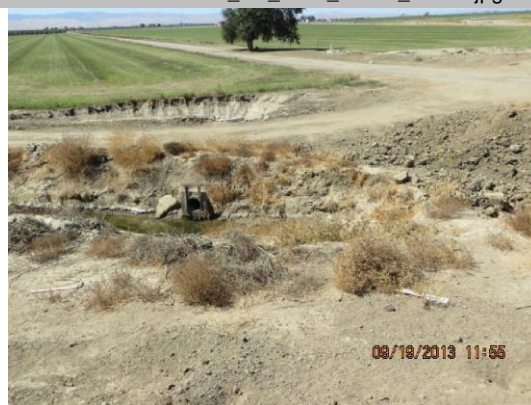
Photo 2 of 3 : UCIP\_SP\_2018\_20875\_35155.jpg

Inlet on LS toe with concrete headwall.

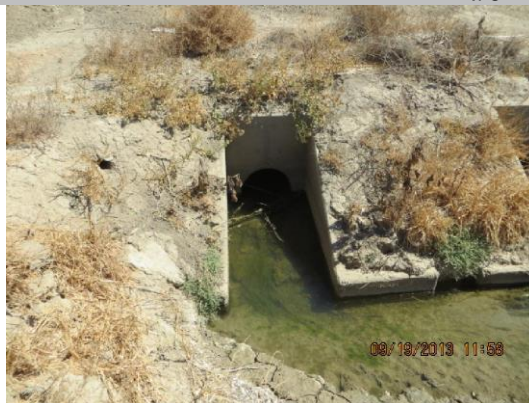
Photo 3 of 3 : UCIP\_SP\_2018\_20875\_35154.jpg

LM Start	2.87	Rating **	A/W	Issue No.	953 (cont)	
LM End	2.87	Issue Type +	Ma	Location *		
Category	Supplemental			GPS Latitude/Longitude		
				Start	End	
Item	DWR UCIP LMA Responsibility			37.639924 °	37.639924 °	
				-121.230005 °	-121.230005 °	
DWR ID						
Comment Code						
Inspector Comment						
FS_ID:20875						
DS_ID:20707						
EP_NO: N/A						
Repair Type: No Action Needed						
Crossing Status: Found						
UCIP Comments:						
FIELD_STRUCT_DESC: 1 of 2: 24-inch corrugated metal drainage pipe						
through the levee, 12.5 feet below the crown. Concrete U-shaped						
headwalls on each end. Flap gate on the waterside (WS) end.						
[Additional Reference(s): DWR Levee Log, 1992. USACE San Joaquin						
O&M Manual 12, December 1968, (HLM 2.89)].						
FS Date: 9/19/2013

Inlet on LS toe with concrete headwall.

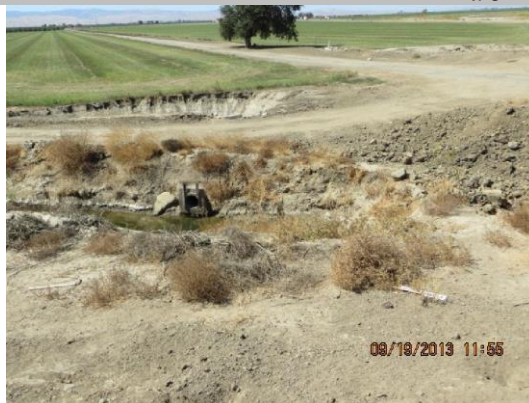
Photo 1 of 3 : UCIP\_SP\_2018\_20876\_35159.jpg

LM Start	2.87	Rating **	A/W	Issue No.	954
LM End	2.87	Issue Type +	Ma	Location *	
Category	Supplemental			GPS Latitude/Longitude	
				Start	End
Item	DWR UCIP LMA Responsibility			37.639884 °	37.639884 °
				-121.230008 °	-121.230008 °
DWR ID					
Comment Code					
Inspector Comment					
FS_ID:20876 DS_ID:20709 EP_NO: N/A Repair Type: No Action Needed Crossing Status: Found UCIP Comments: FIELD_STRUCT_DESC: 2 of 2: 24-inch drainage pipe of an unknown material through the levee, 12.5 feet below the crown. Concrete U-shaped headwalls on each end. Flap gate on the waterside (WS) end. [Additional Reference(s): DWR Levee Log, 1992. USACE San Joaquin O&M Manual 12, December 1968, (HLM 2.89)]. FS Date: 9/19/2013

Concrete inlet on LS toe at canal.

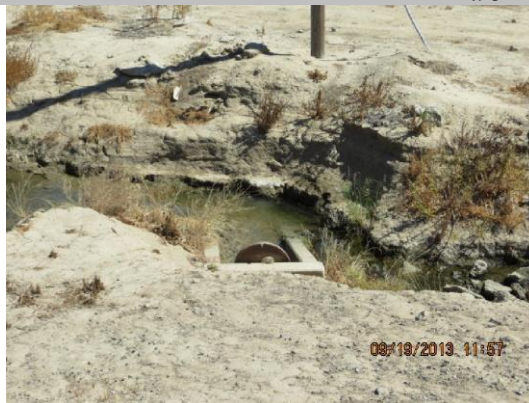
Photo 2 of 3 : UCIP\_SP\_2018\_20876\_35158.jpg

Concrete U-shaped headwall on WS toe with flapgate.

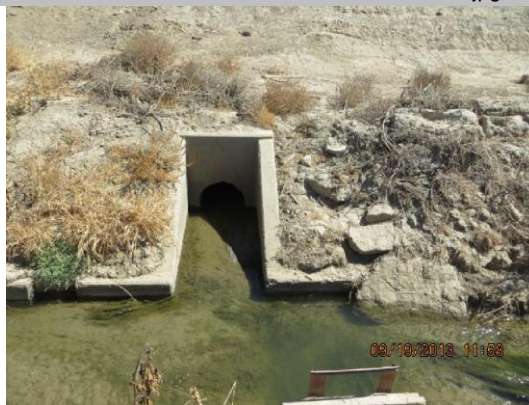
Photo 3 of 3 : UCIP\_SP\_2018\_20876\_35157.jpg

Concrete inlet on LS toe at canal.

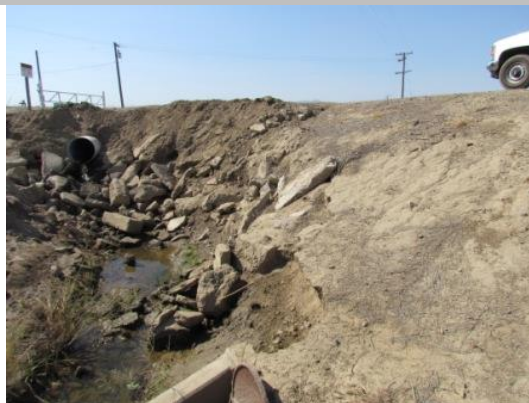
Photo 1 of 2 : SP\_2018\_RD2101\_326\_29\_20180305\_00016.jpg

View of repaired site, but it appears that erosion is still occurring.  
09/25/2012

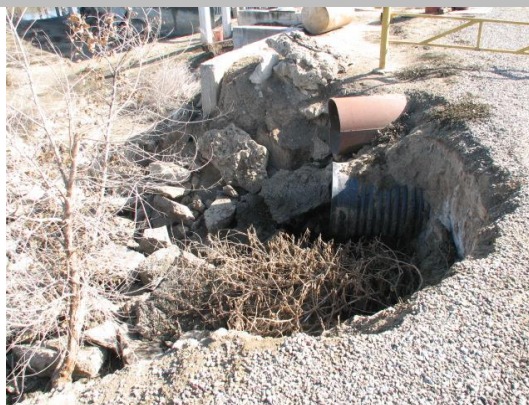
Photo 2 of 2 : SP\_2018\_RD2101\_326\_29\_20180305\_00017.jpg

Levee slope is being eroded at this location. Repair needed to preserve access road.

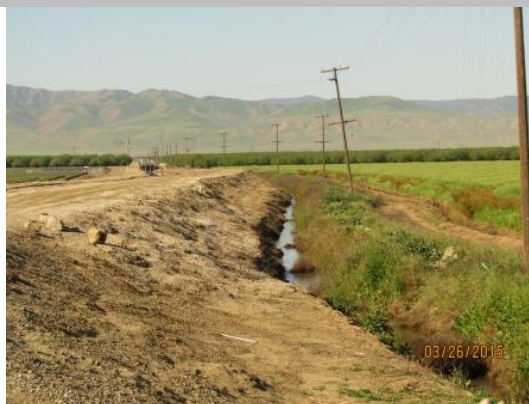
Photo 1 of 1 : SP\_2018\_RD2101\_326\_8\_20180305\_00006.jpg

View of the ditch at the landside levee toe.

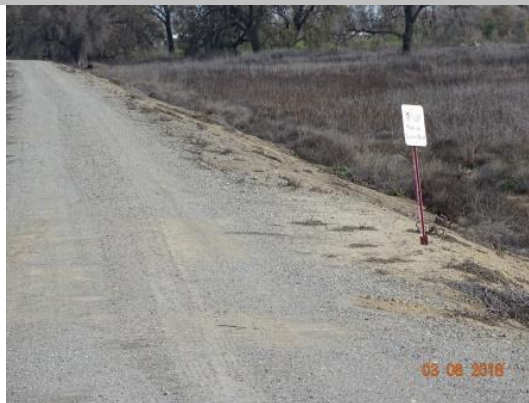
Photo 1 of 1 : SP\_2018\_RD2101\_327\_1\_20180308\_00001.jpg

View of the acceptable vegetation control on the levee slope.
